**Examples**

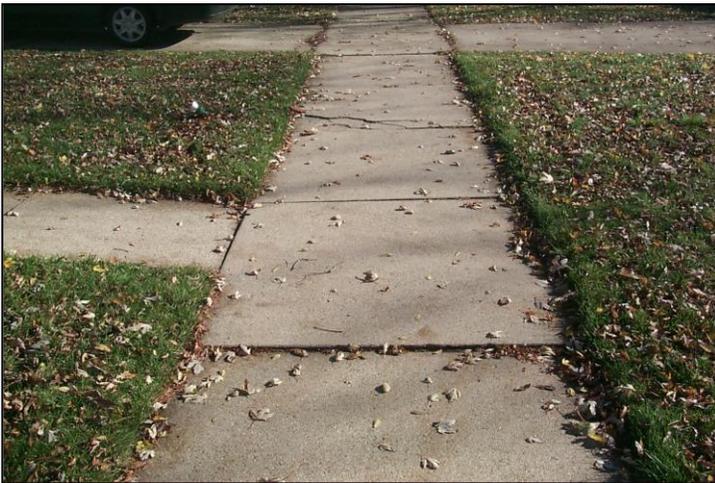
**Figure 1 – Sidewalk Trip Hazard (1 1/8" or Greater)**

The sidewalk squares should be replaced from the trip hazard to the cracks. If proper drainage is achieved, the new walk should be finished to meet the service walk. Depending on the grades, the adjacent square of service walk may need to be replaced also.

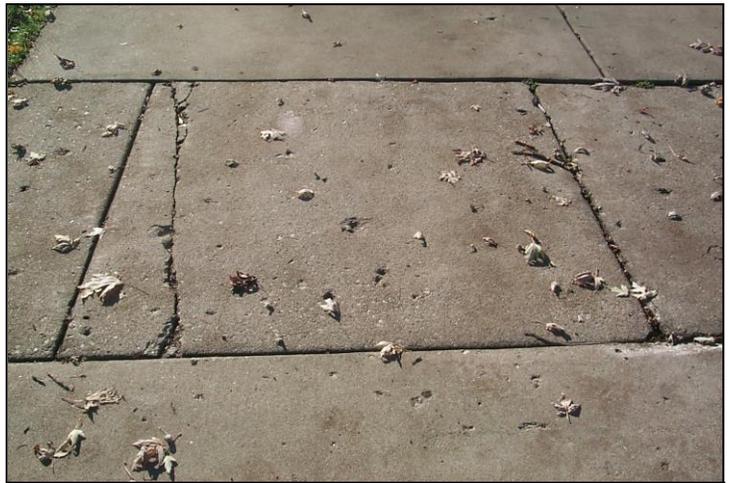
**Figure 2 – Crack in Sidewalk**

Although this sidewalk is cracked, it is not a trip hazard. The crack is beginning to spall, but not severely. The Engineer may decide to replace this walk depending on factors such as potential future deterioration, loose concrete material, or evidence of settlement.

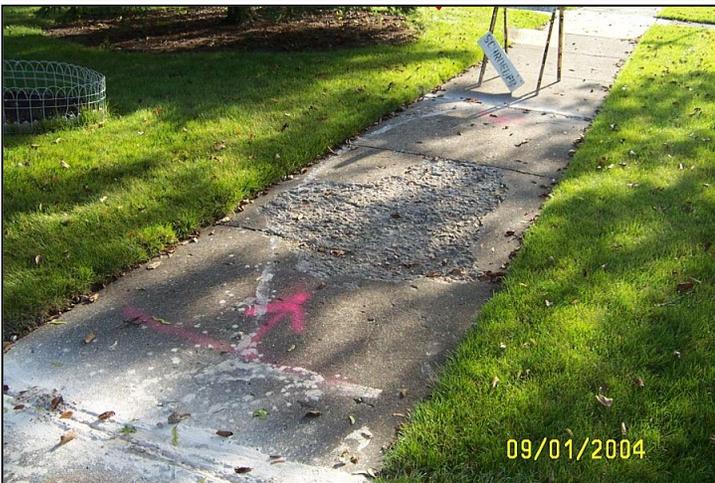
**Figure 3 – Deteriorated Sidewalk**

Obvious deterioration like this should be replaced.

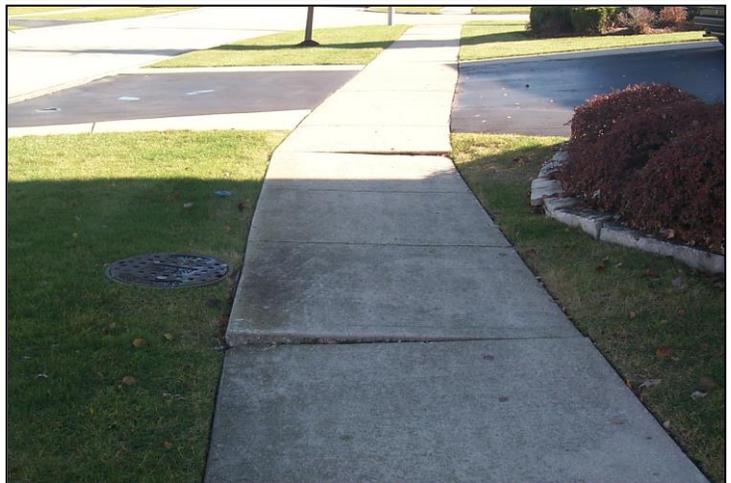
**Figure 4 – Tilting Sidewalk**

This sidewalk should be replaced. Rebar should be placed in the new section of walk due to the adjacent sewer manhole.

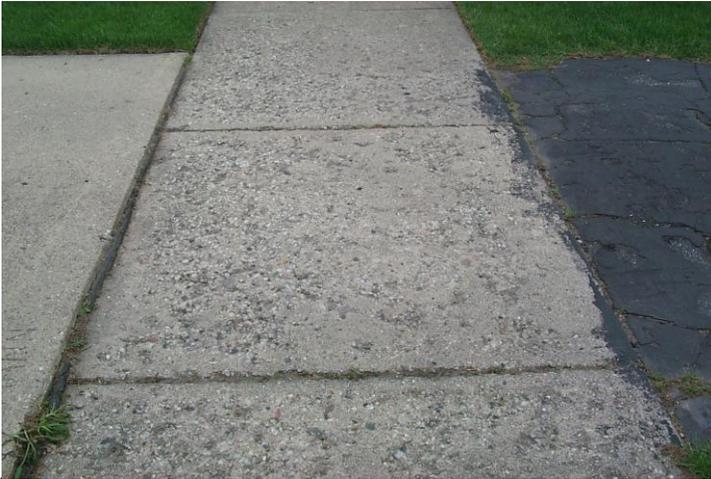
**Figure 5 – Pitted Sidewalk**

This walk should be replaced. Note that the adjacent driveway apron will need to be patched due to its poor condition.

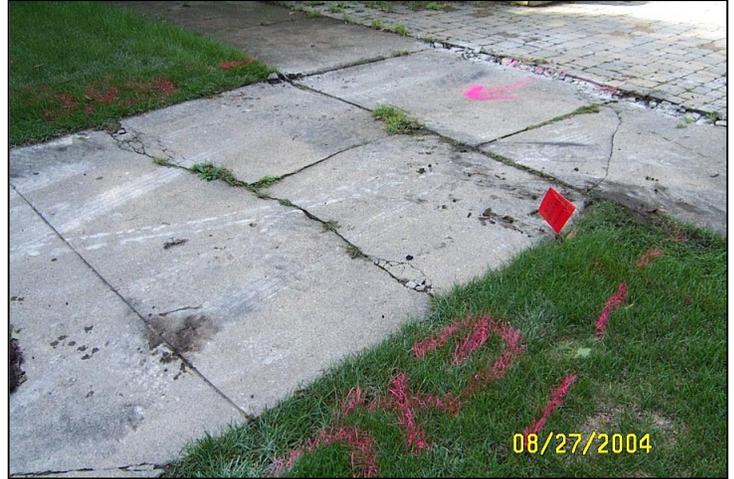
**Figure 6 – Cracked Sidewalk and Apron**

The sidewalk squares are cracked and settled and should be replaced. The Apron is also in poor condition and should be replaced.

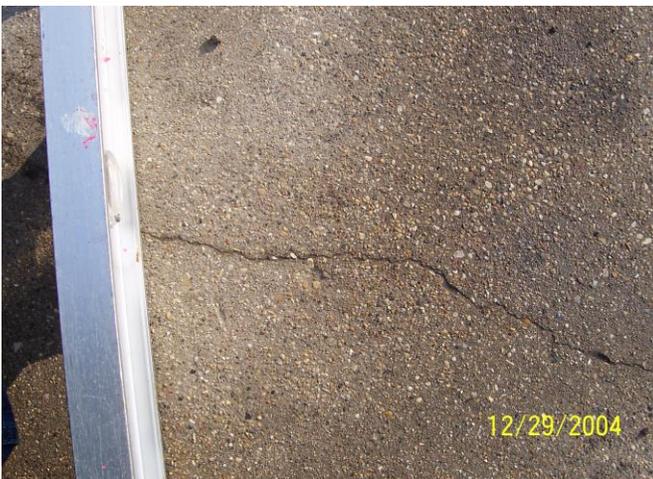
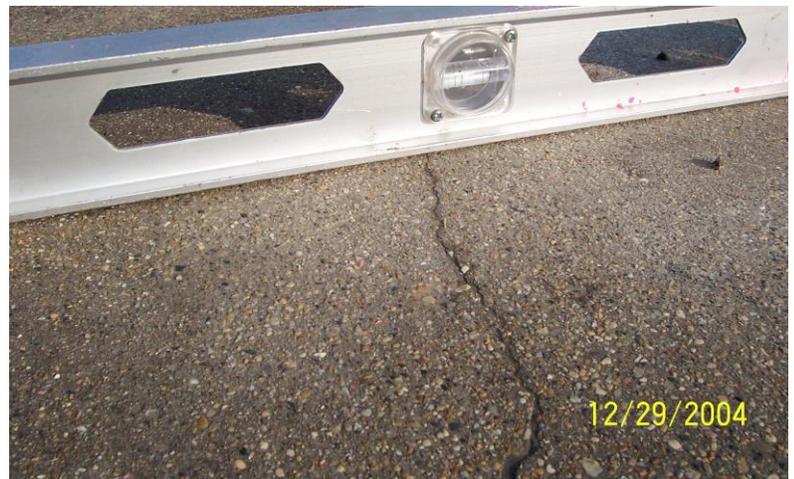
**Figures 7 & 8 – Hairline Crack in Sidewalk**

There is a small crack in this sidewalk, but the walk is in good condition and does not need to be replaced. The crack is not a trip hazard, and there are no signs of spalling, chipping or further deterioration.

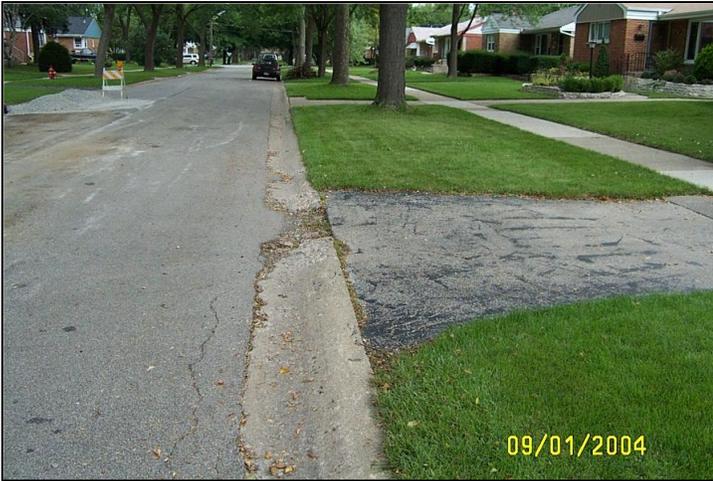
**Figure 9 - Deteriorated Curb, Asphalt Apron**

The curb should be replaced through the entire driveway. The apron is in good enough condition to repair behind the curb with an asphalt patch. The street will require a patch that extends out to incorporate the pavement crack.

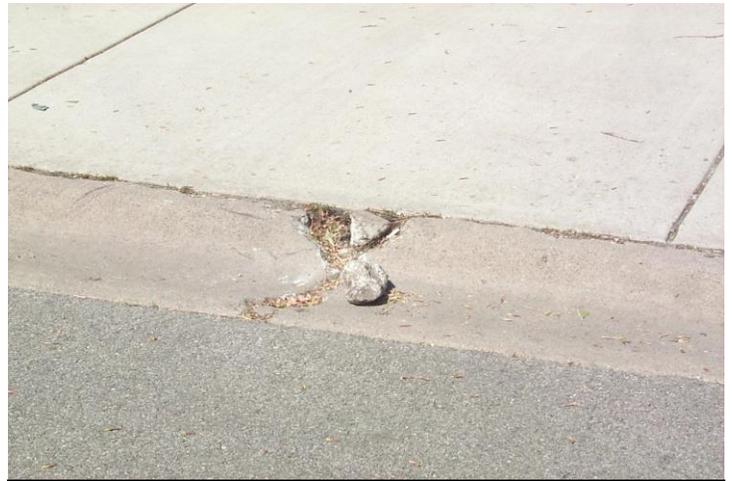
**Figure 10 – Broken Curb, Concrete Apron**

The broken section of curb should be replaced. The driveway apron is in good condition and should not be replaced. The street is in good condition, and the contractor should aim for minimal damage to the street when removing the curb.

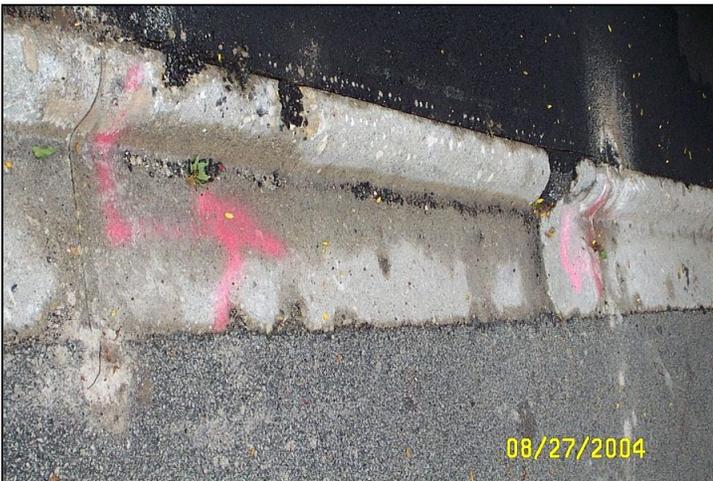
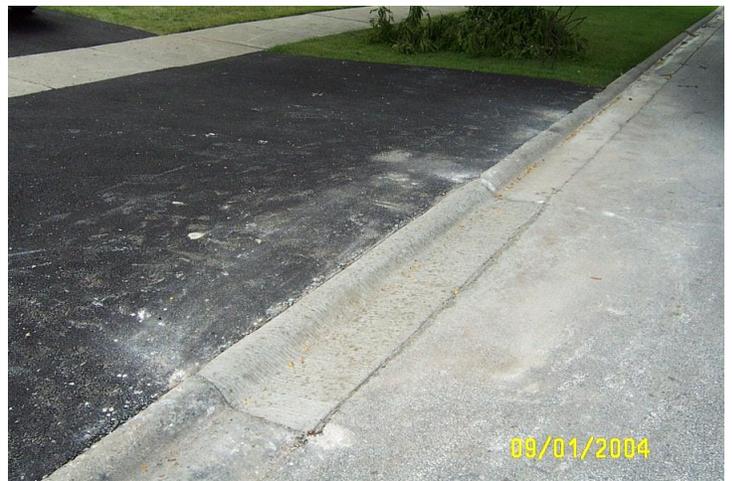
**Figures 11 & 12 - Deteriorated Curb, Asphalt Apron (Before and After)**

Although this curb is not in poor condition, there are several chips and spalls that were patched with asphalt. Only this short section of curb should be replaced. Care should be taken to protect both the street and driveway since both are in good condition. In this case, the new curb should not be depressed.

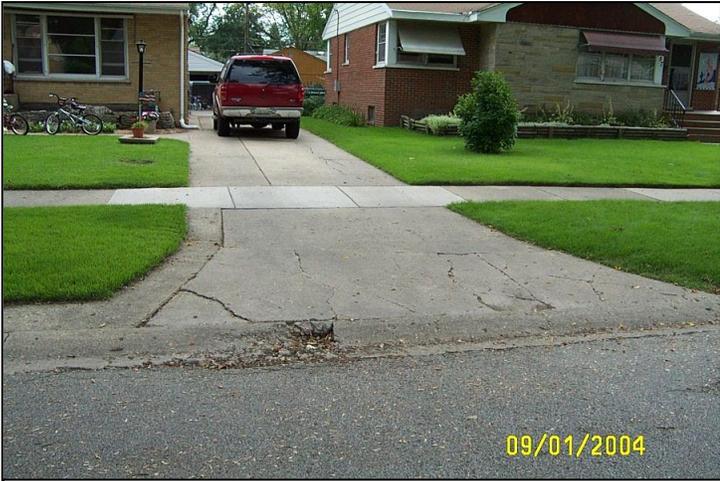
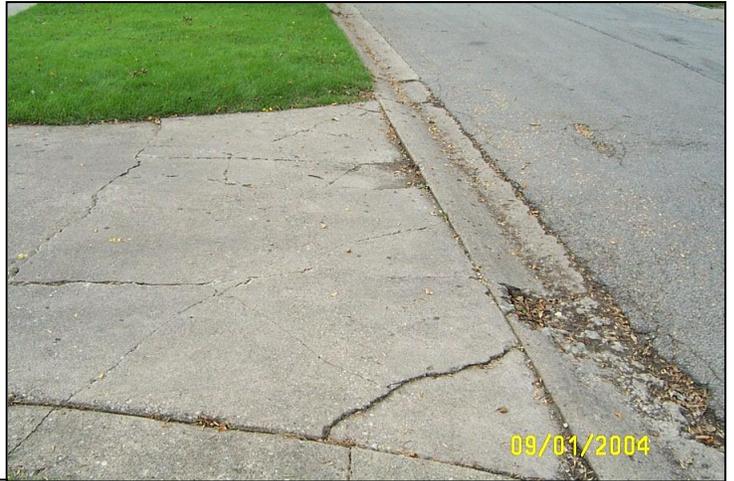
**Figures 13 & 14 - Deteriorated Curb and Cracked Apron**

The curb should be replaced at a minimum through the left half of the driveway. The apron is in poor condition and should be replaced also. Note that the sidewalk has already been replaced through the driveway. The curb should be replaced as a depressed curb instead of a rolled curb. The street will require a full depth patch where the curb is deteriorated.

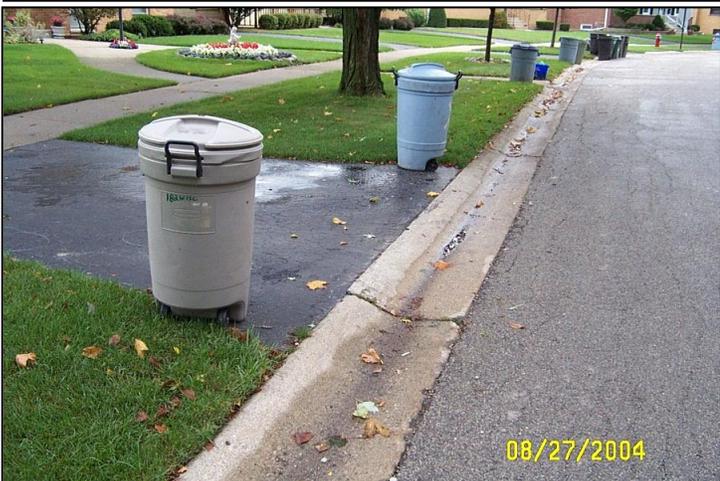
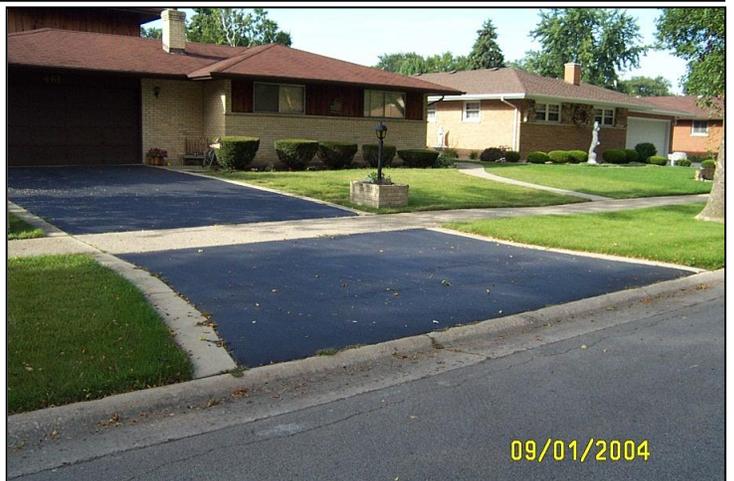
**Figures 15 & 16 – Rolled Curb in Good Condition**

These are two examples of rolled curb that is in good condition. The aprons are also in good condition. No replacement should be done.
